Navajo Abandoned Uranium Mine

Site Screen Report

Joe Ben 1 AUM Site

March 2010

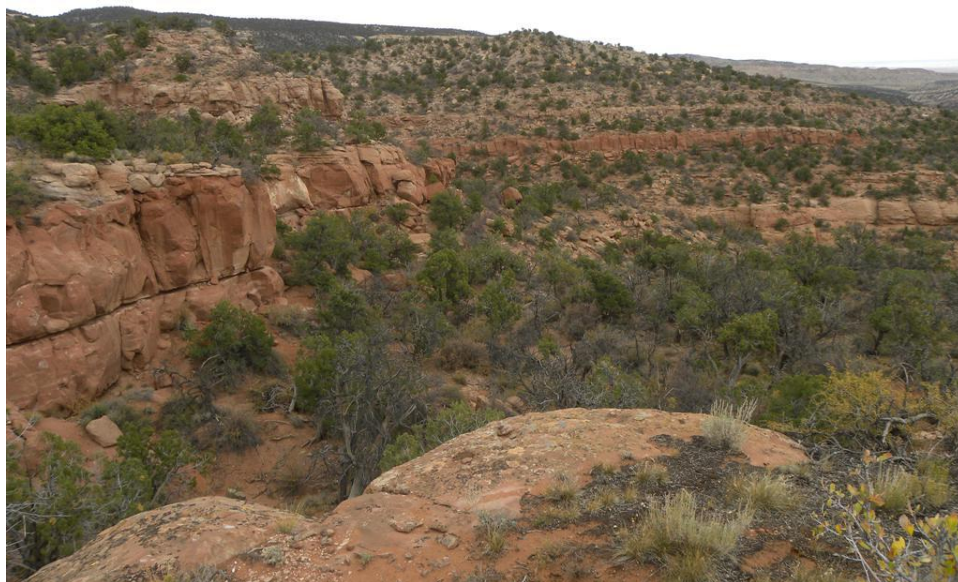
Photo 1. View of mine site in distance

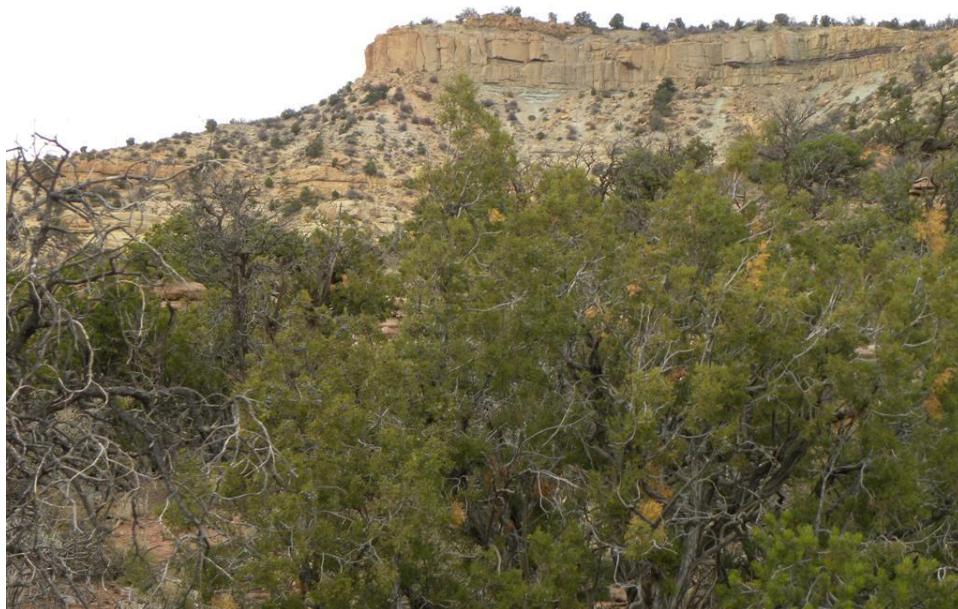
Photo 2. View of mine site in distance

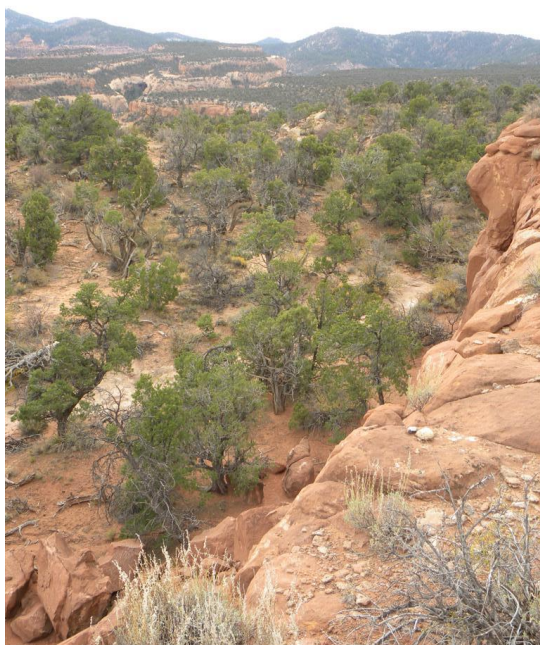
Photo 3. View down towards mine site
